# Seiche & Winter Preparedness

Roy Widrig

Great Lakes Coastal  
Processes and Hazards

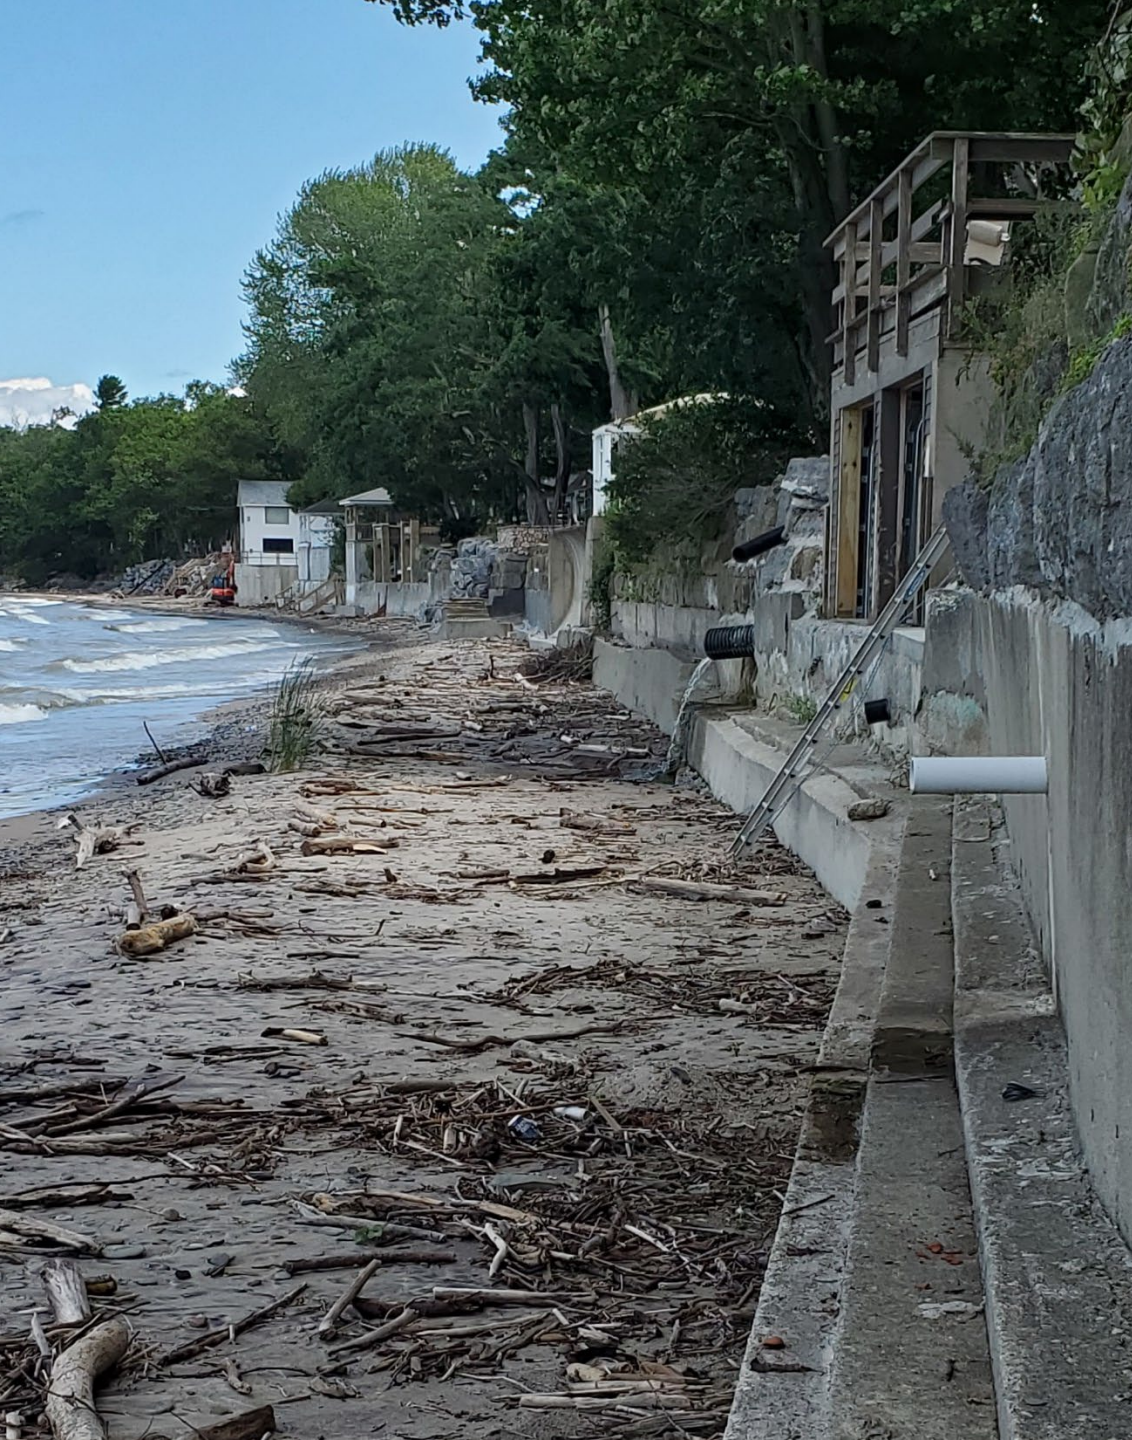
# Verticality

- Often - Vertical, concrete walls along the shoreline
- Waves impact the shoreline at high strength – no dispersal
- Nearshore scouring
- Often a lack of drainage (waves overwash and cannot dissipate over a beach)

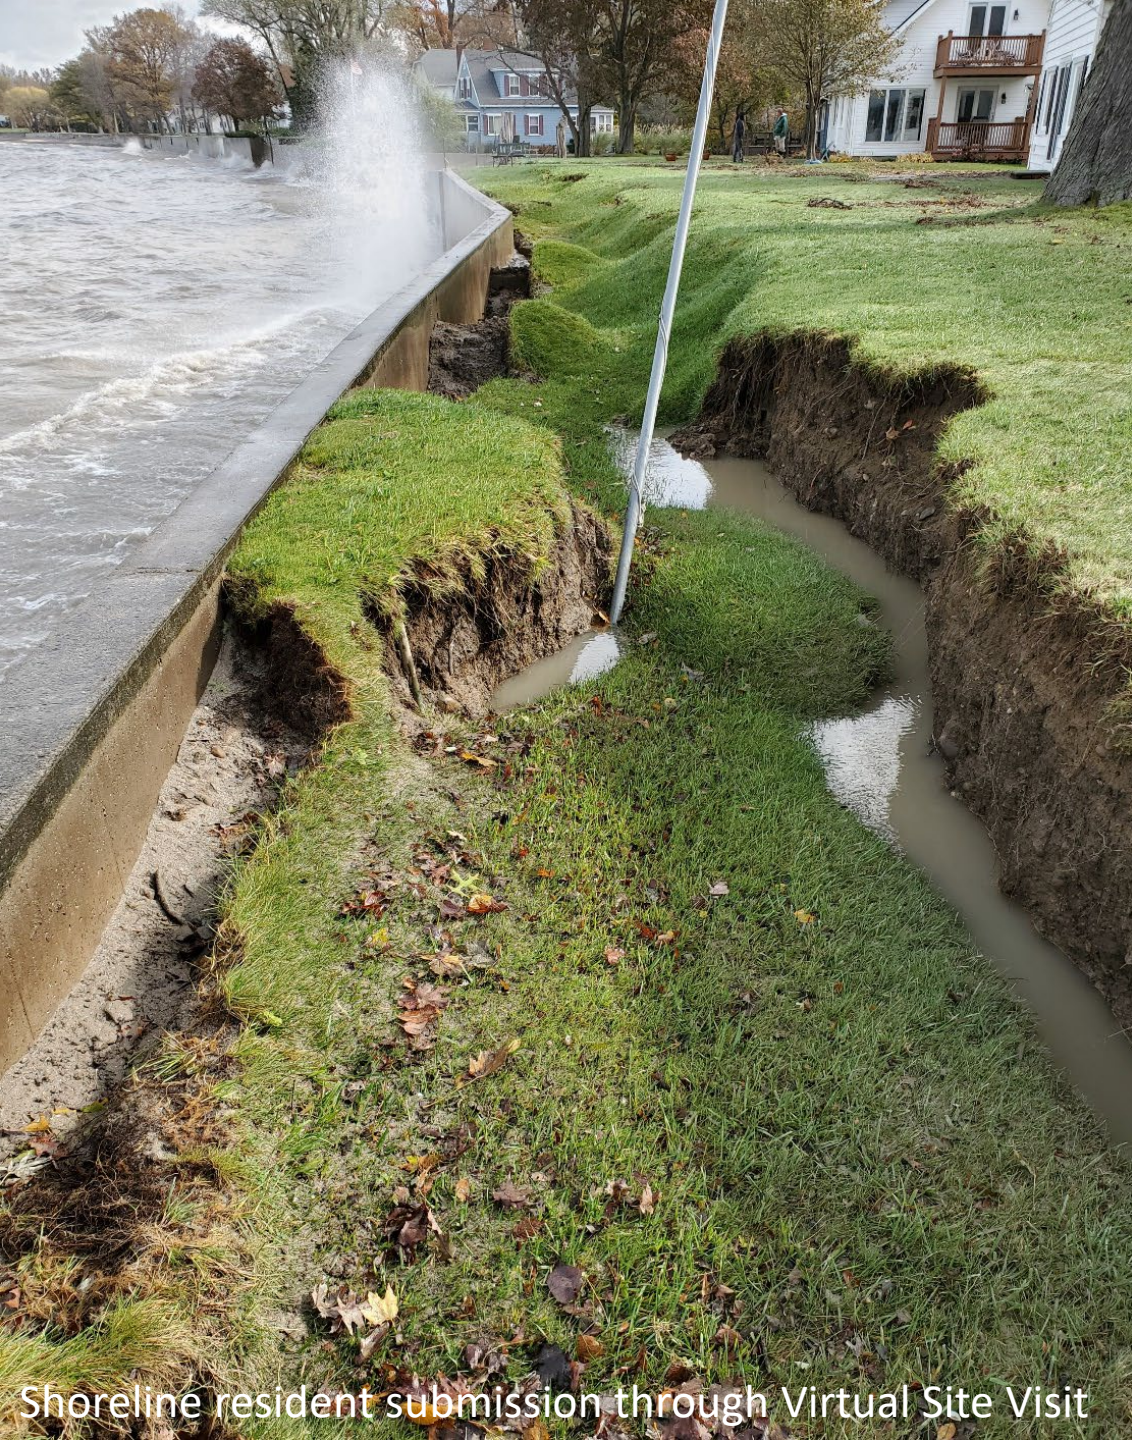
# Drainage

- Pressure builds behind walls
- Seiche overwash unable to drain naturally
- Accelerated by runoff from storm events (heavy rain, snowmelt) and lakeshore roads
- Proper drainage extends the life of shoreline armor, prevents standing water

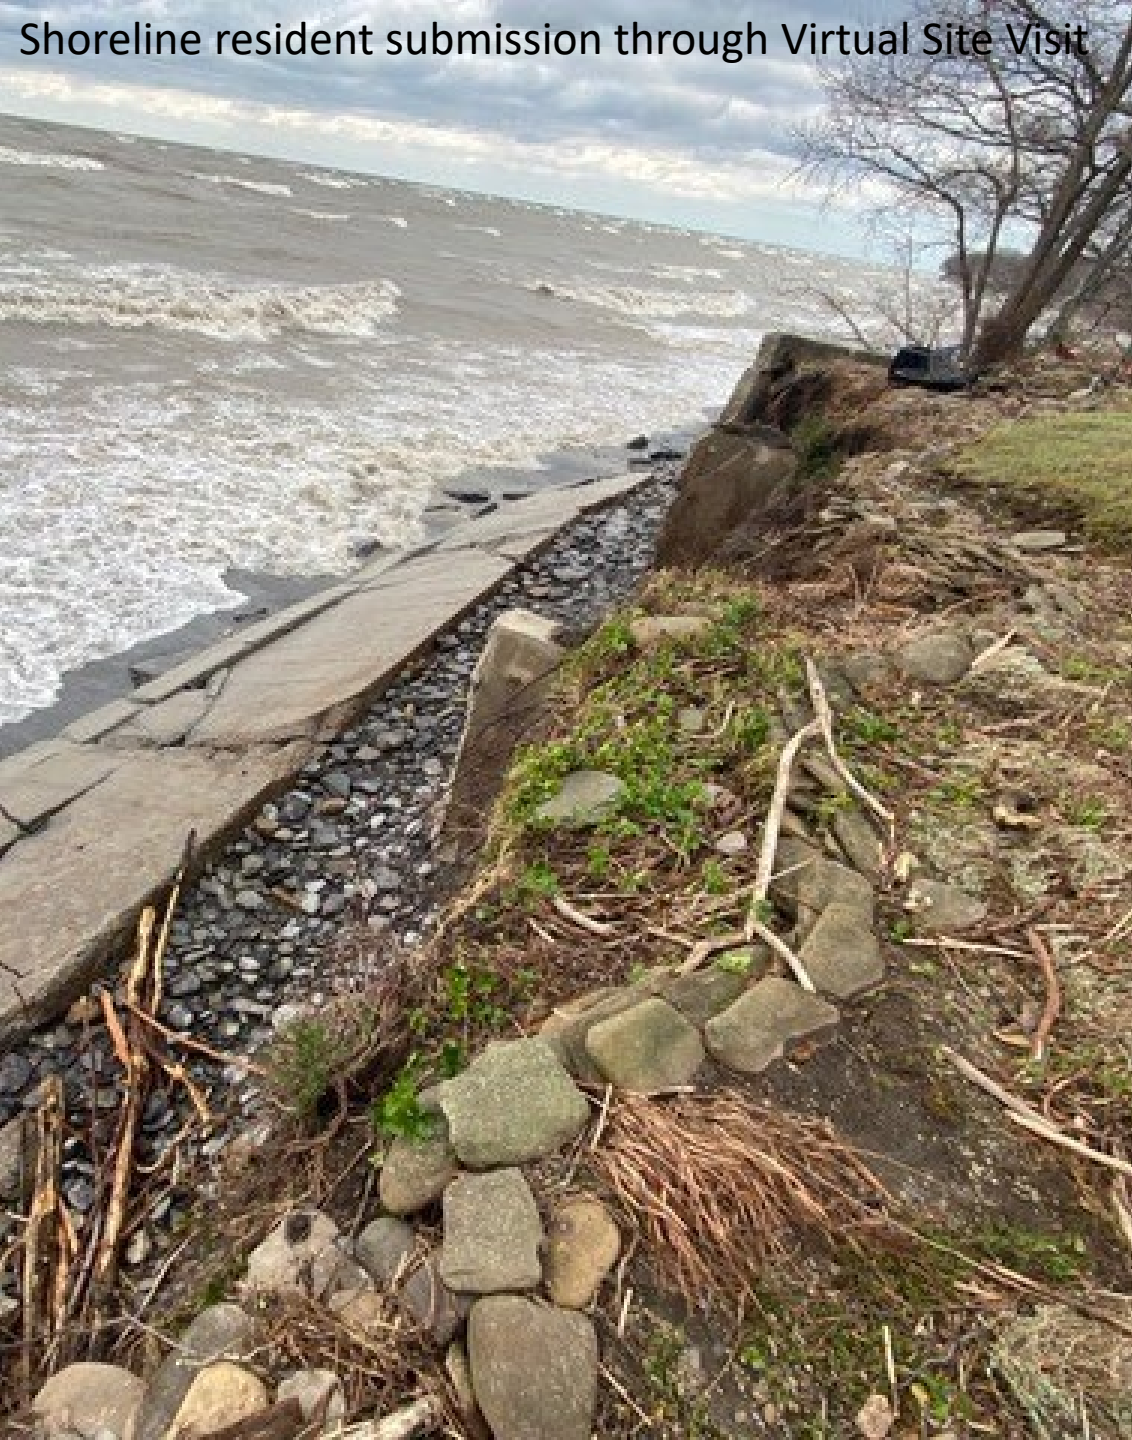
- Build into original designs – preparedness
- Limit soil compaction behind walls – utilize vegetation
- Avoid vertical shoreline protection measures

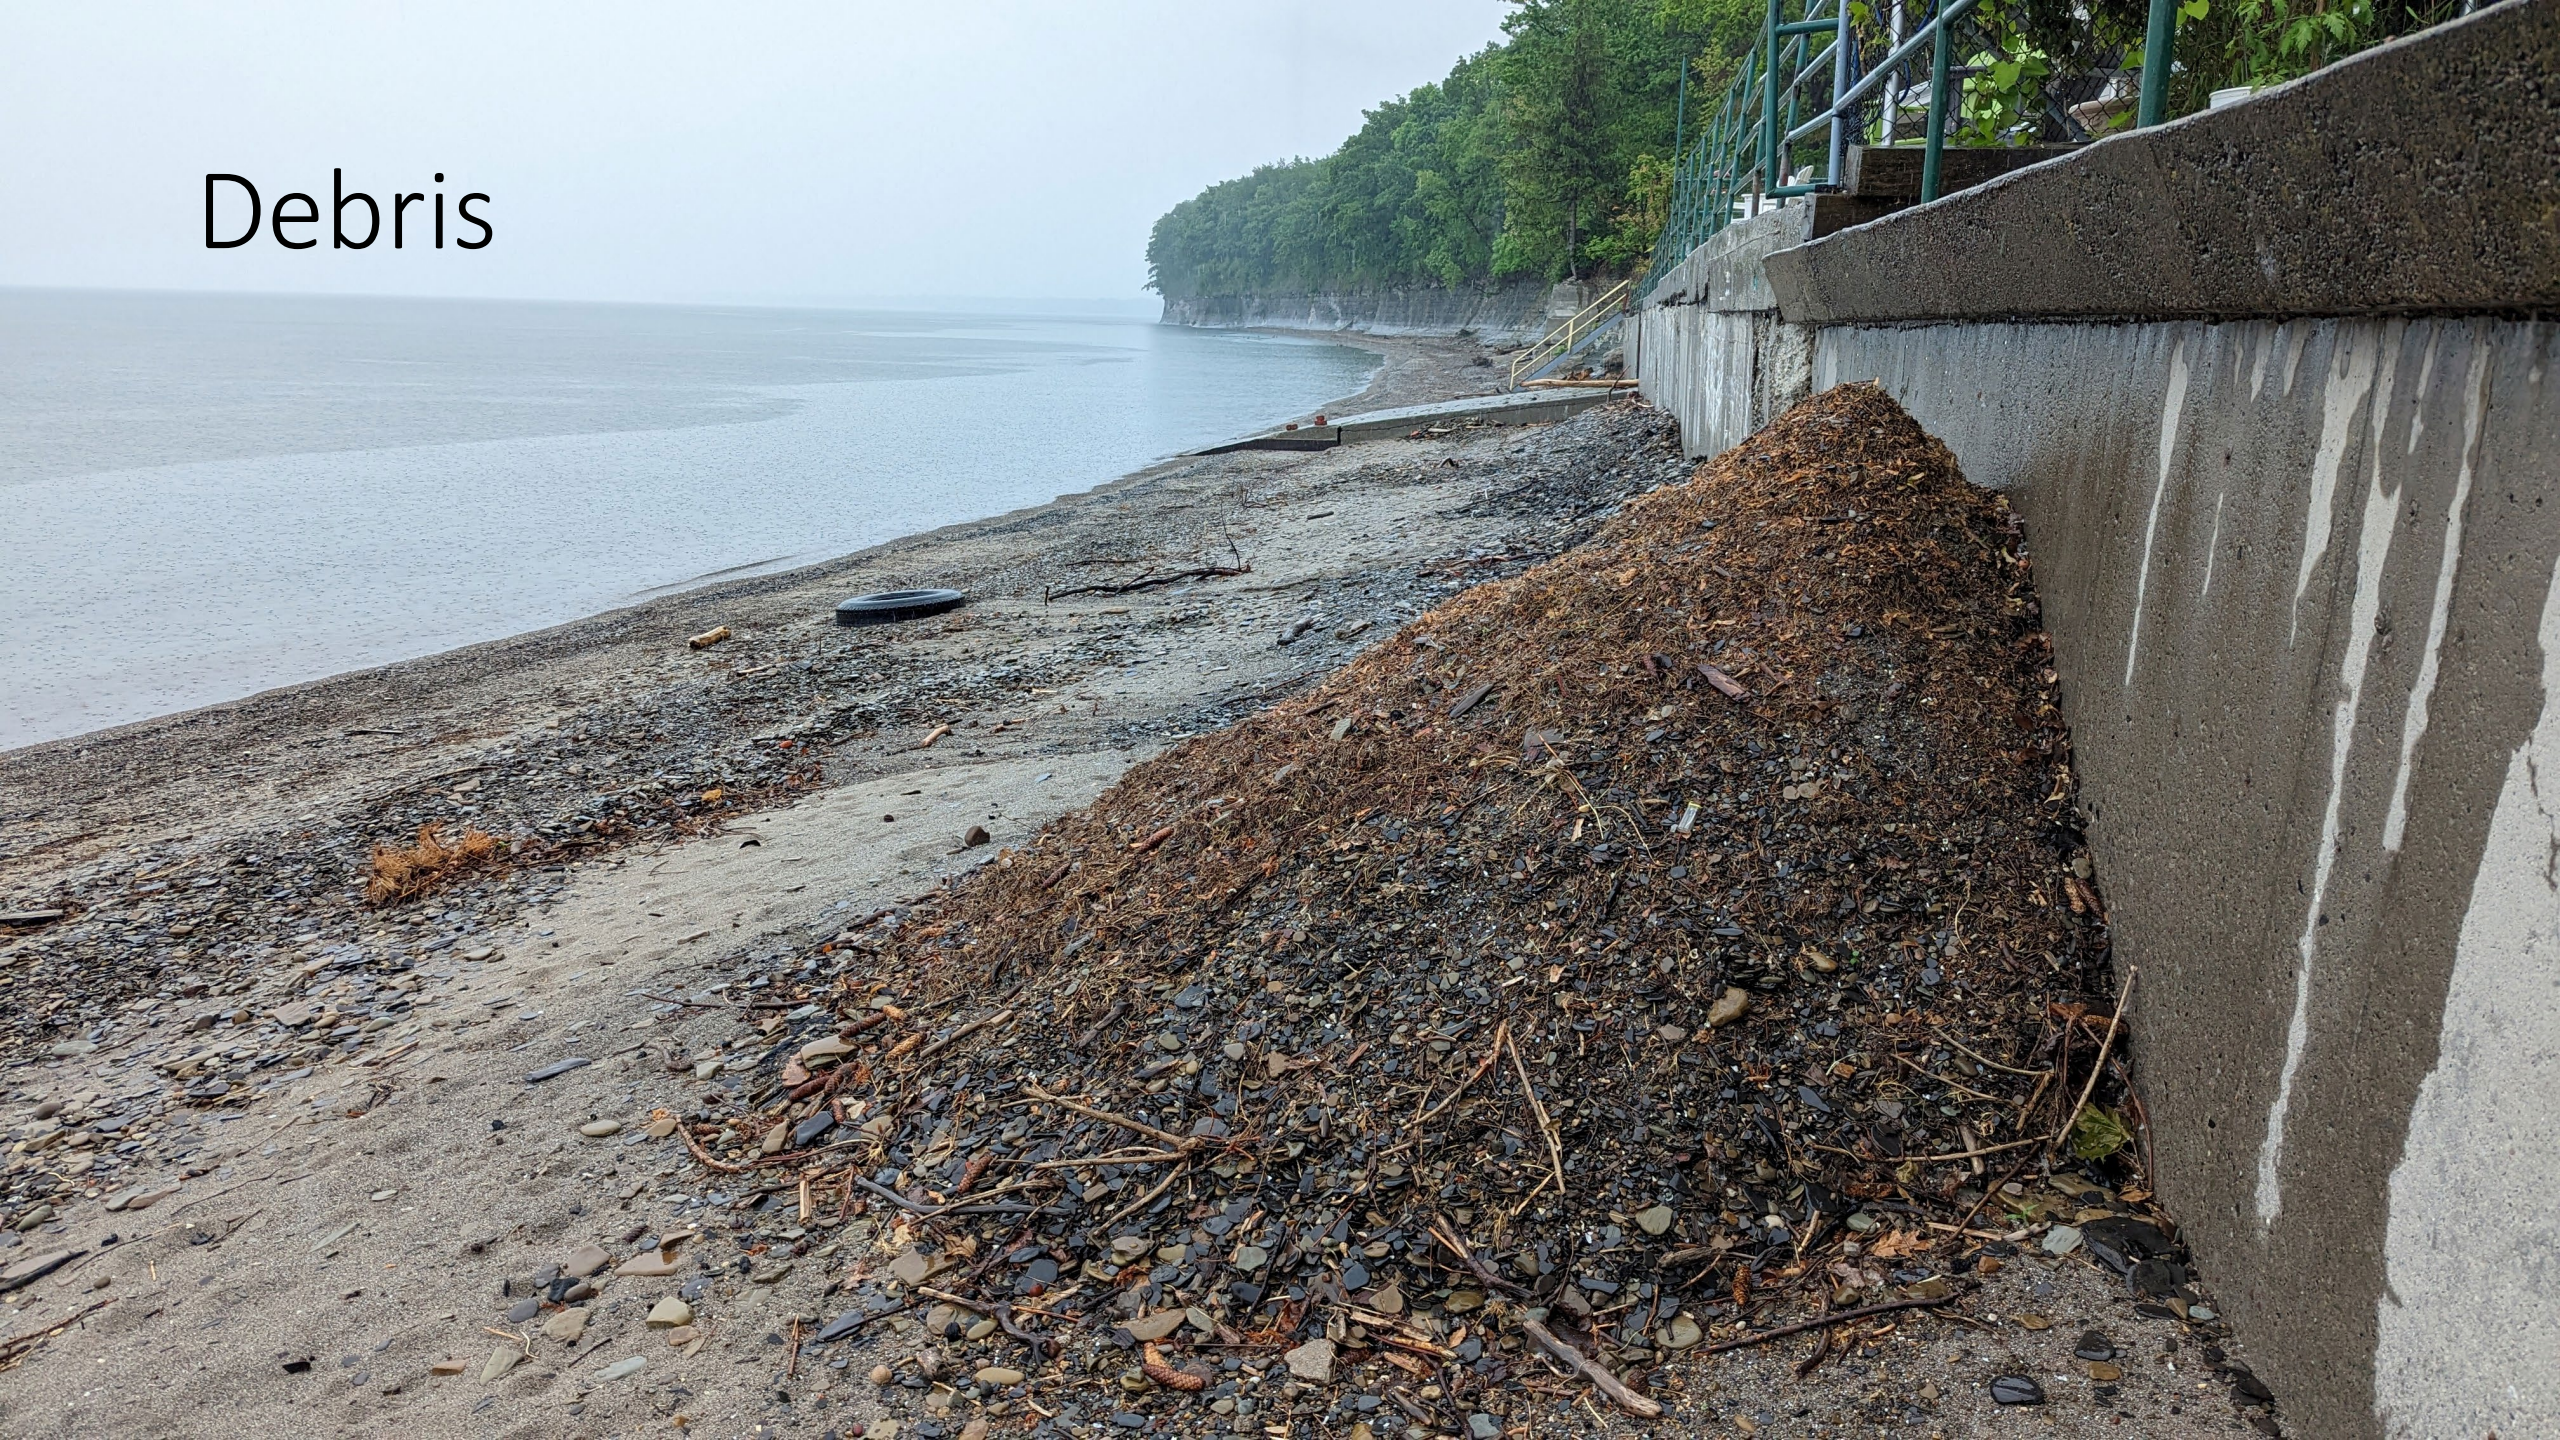
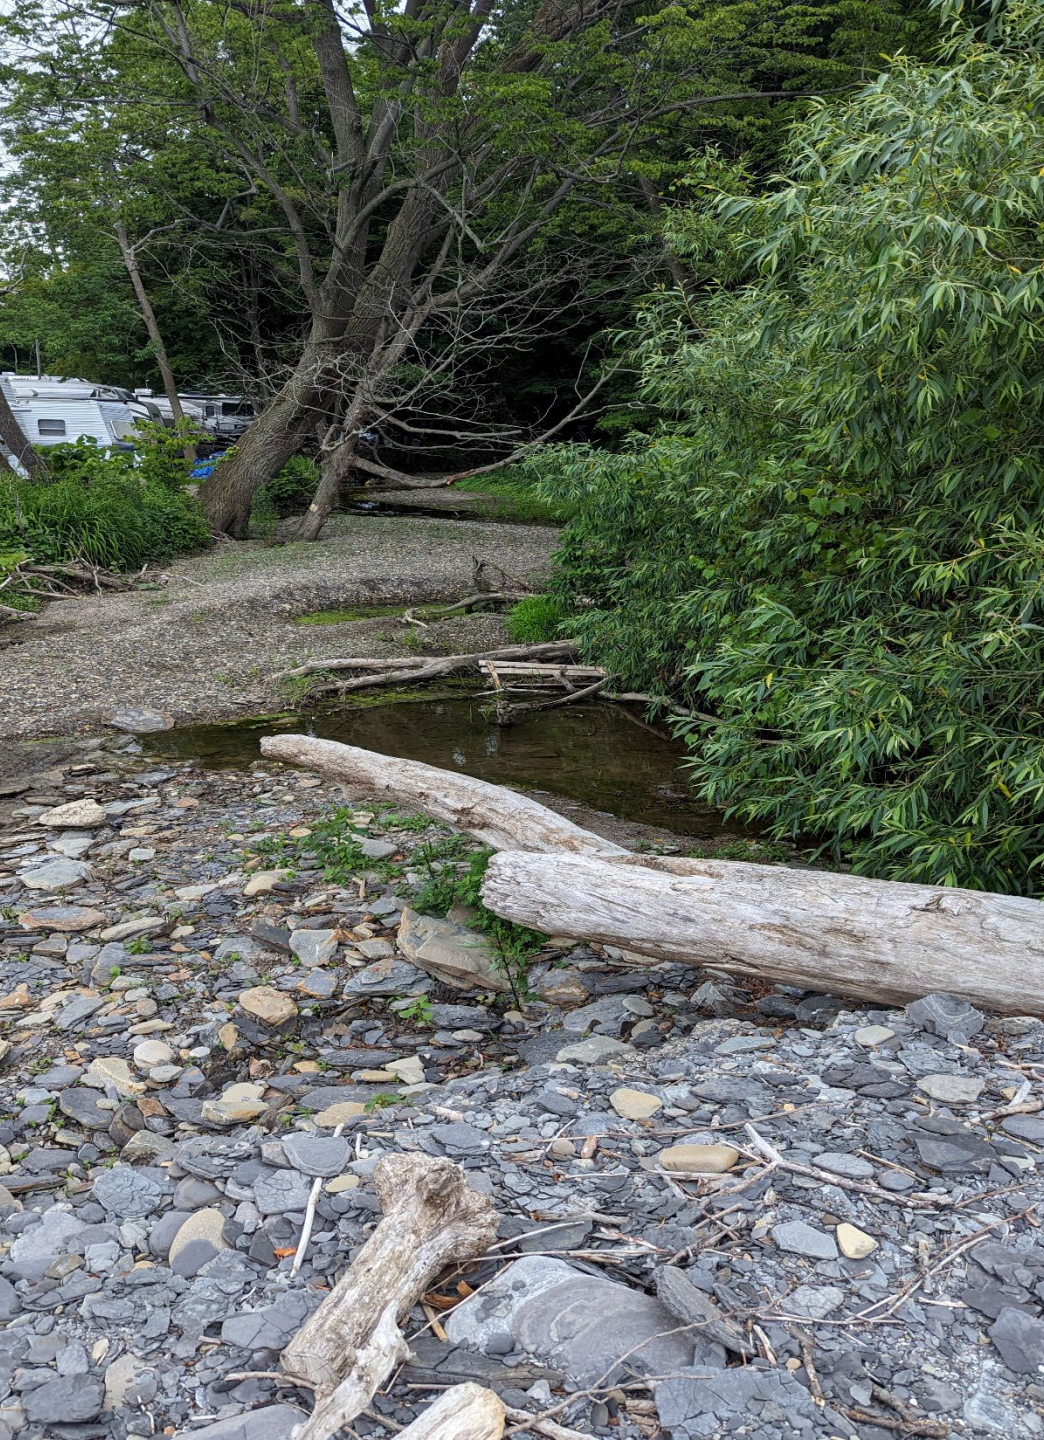
# Debris

- Woody debris, plastic, concrete, rocks, sand
  - Have a community plan for removal
- Site by site and event by event
  - Could it be locally beneficial?
- Shoreline shape, exposure, specific storm events
- Winter preparedness – window boarding, shoreline vegetation\*

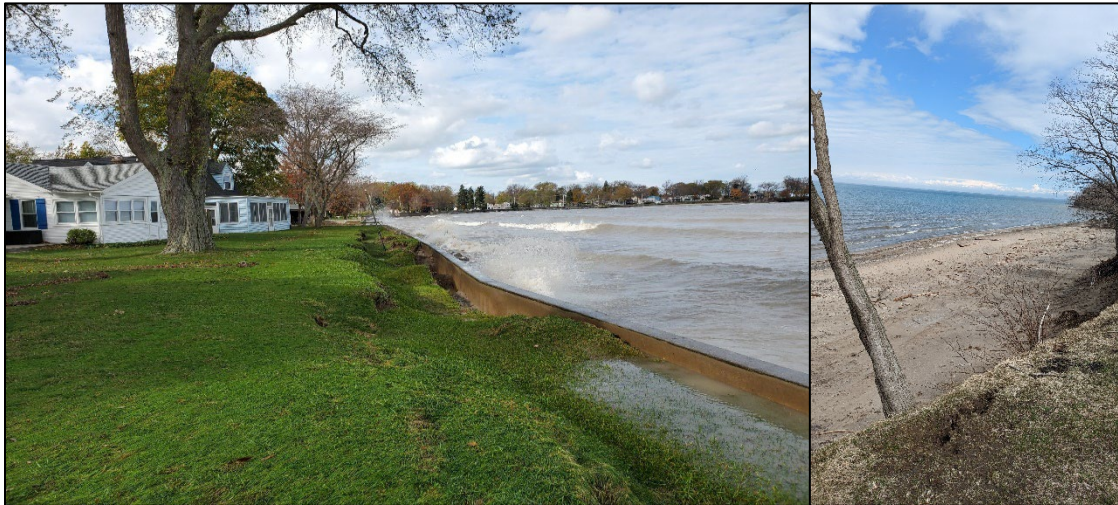
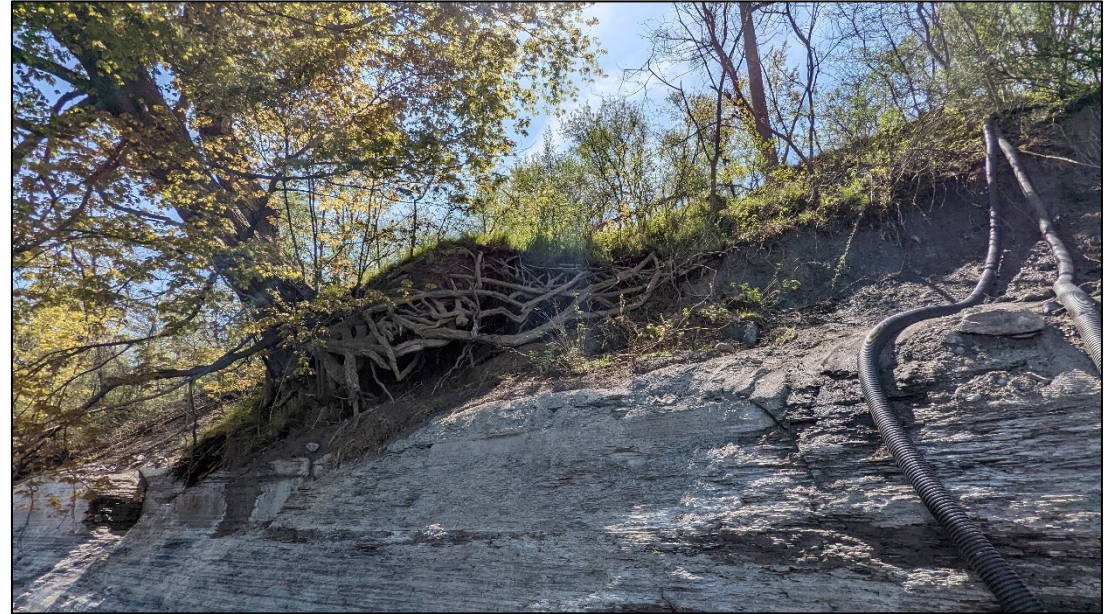
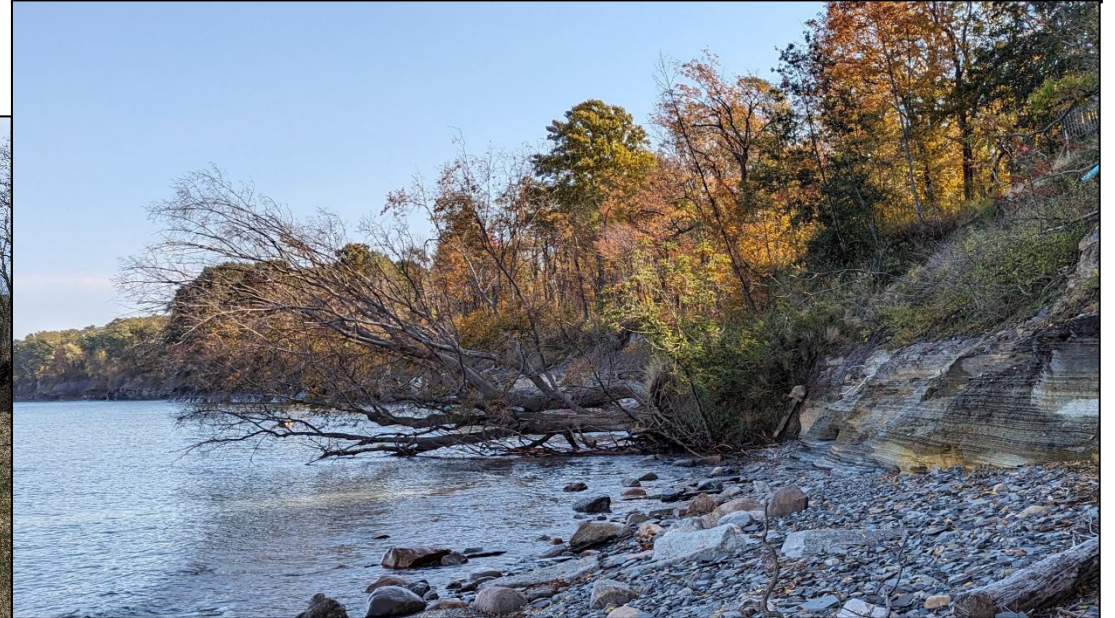
May 2022

October 2023

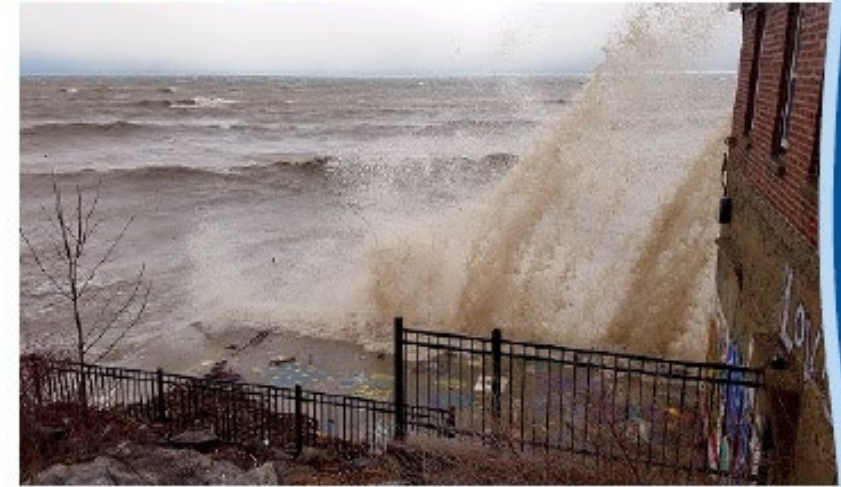
Seiche waves blast a shoreline structure in Buffalo, NY in April 2018. Photo by New York State Department of Environmental Conservation.
